CONNECTICUT RIVER BASIN  
SANDSFIELD, MASSACHUSETTS

WEST LAKE DAM  
MA 00288

PHASE I INSPECTION REPORT  
NATIONAL DAM INSPECTION PROGRAM

DECEMBER 1979

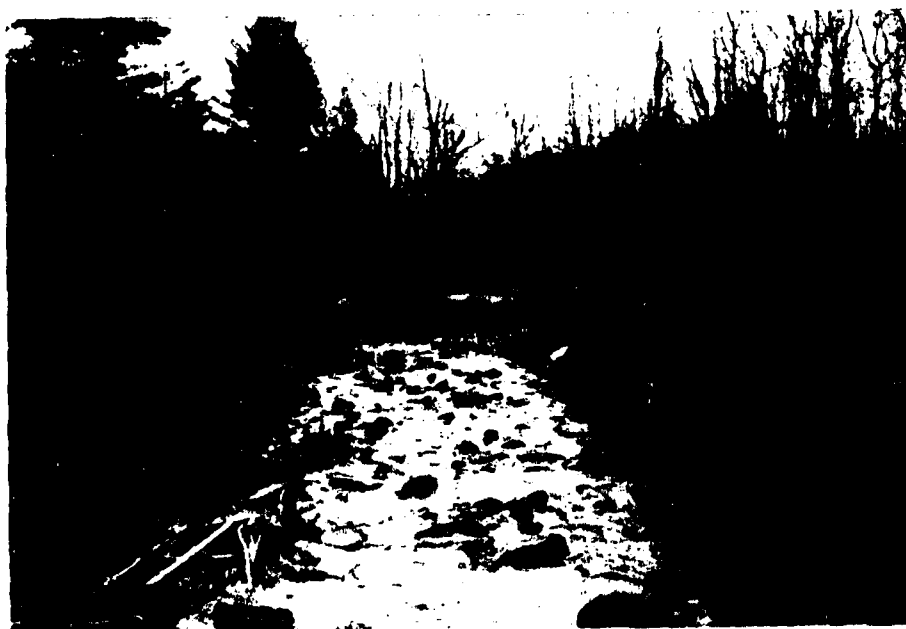
PHOTO 8

Toe drain pipe outlet flow with blockage removed

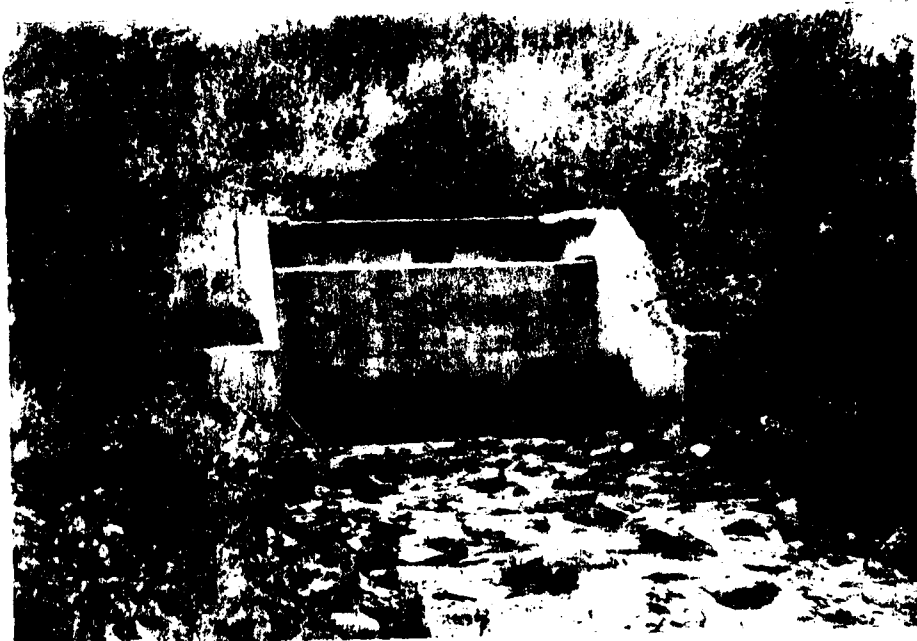
PHOTO 5

At the location where the conduit enters the impact basin, the joint around the conduit has some grass growth between the pipe and the concrete structure, through the jointing material. The jointing material was found intact, but loose, around the pipe. No significant water or sand leakage was observed during our inspection.

Impact basin structure  
at outlet of 36" prin-  
cipal spillway conduit.  
Note grass growth from  
drain pipe outlet
